CALIFORNIA DIVISION OF MINES AND GEOLOGY

FAULT EVALUATION REPORT FER-88

March 19, 1979

Hayward, Mission and Calaveras faults, segments in Niles quadrangle.

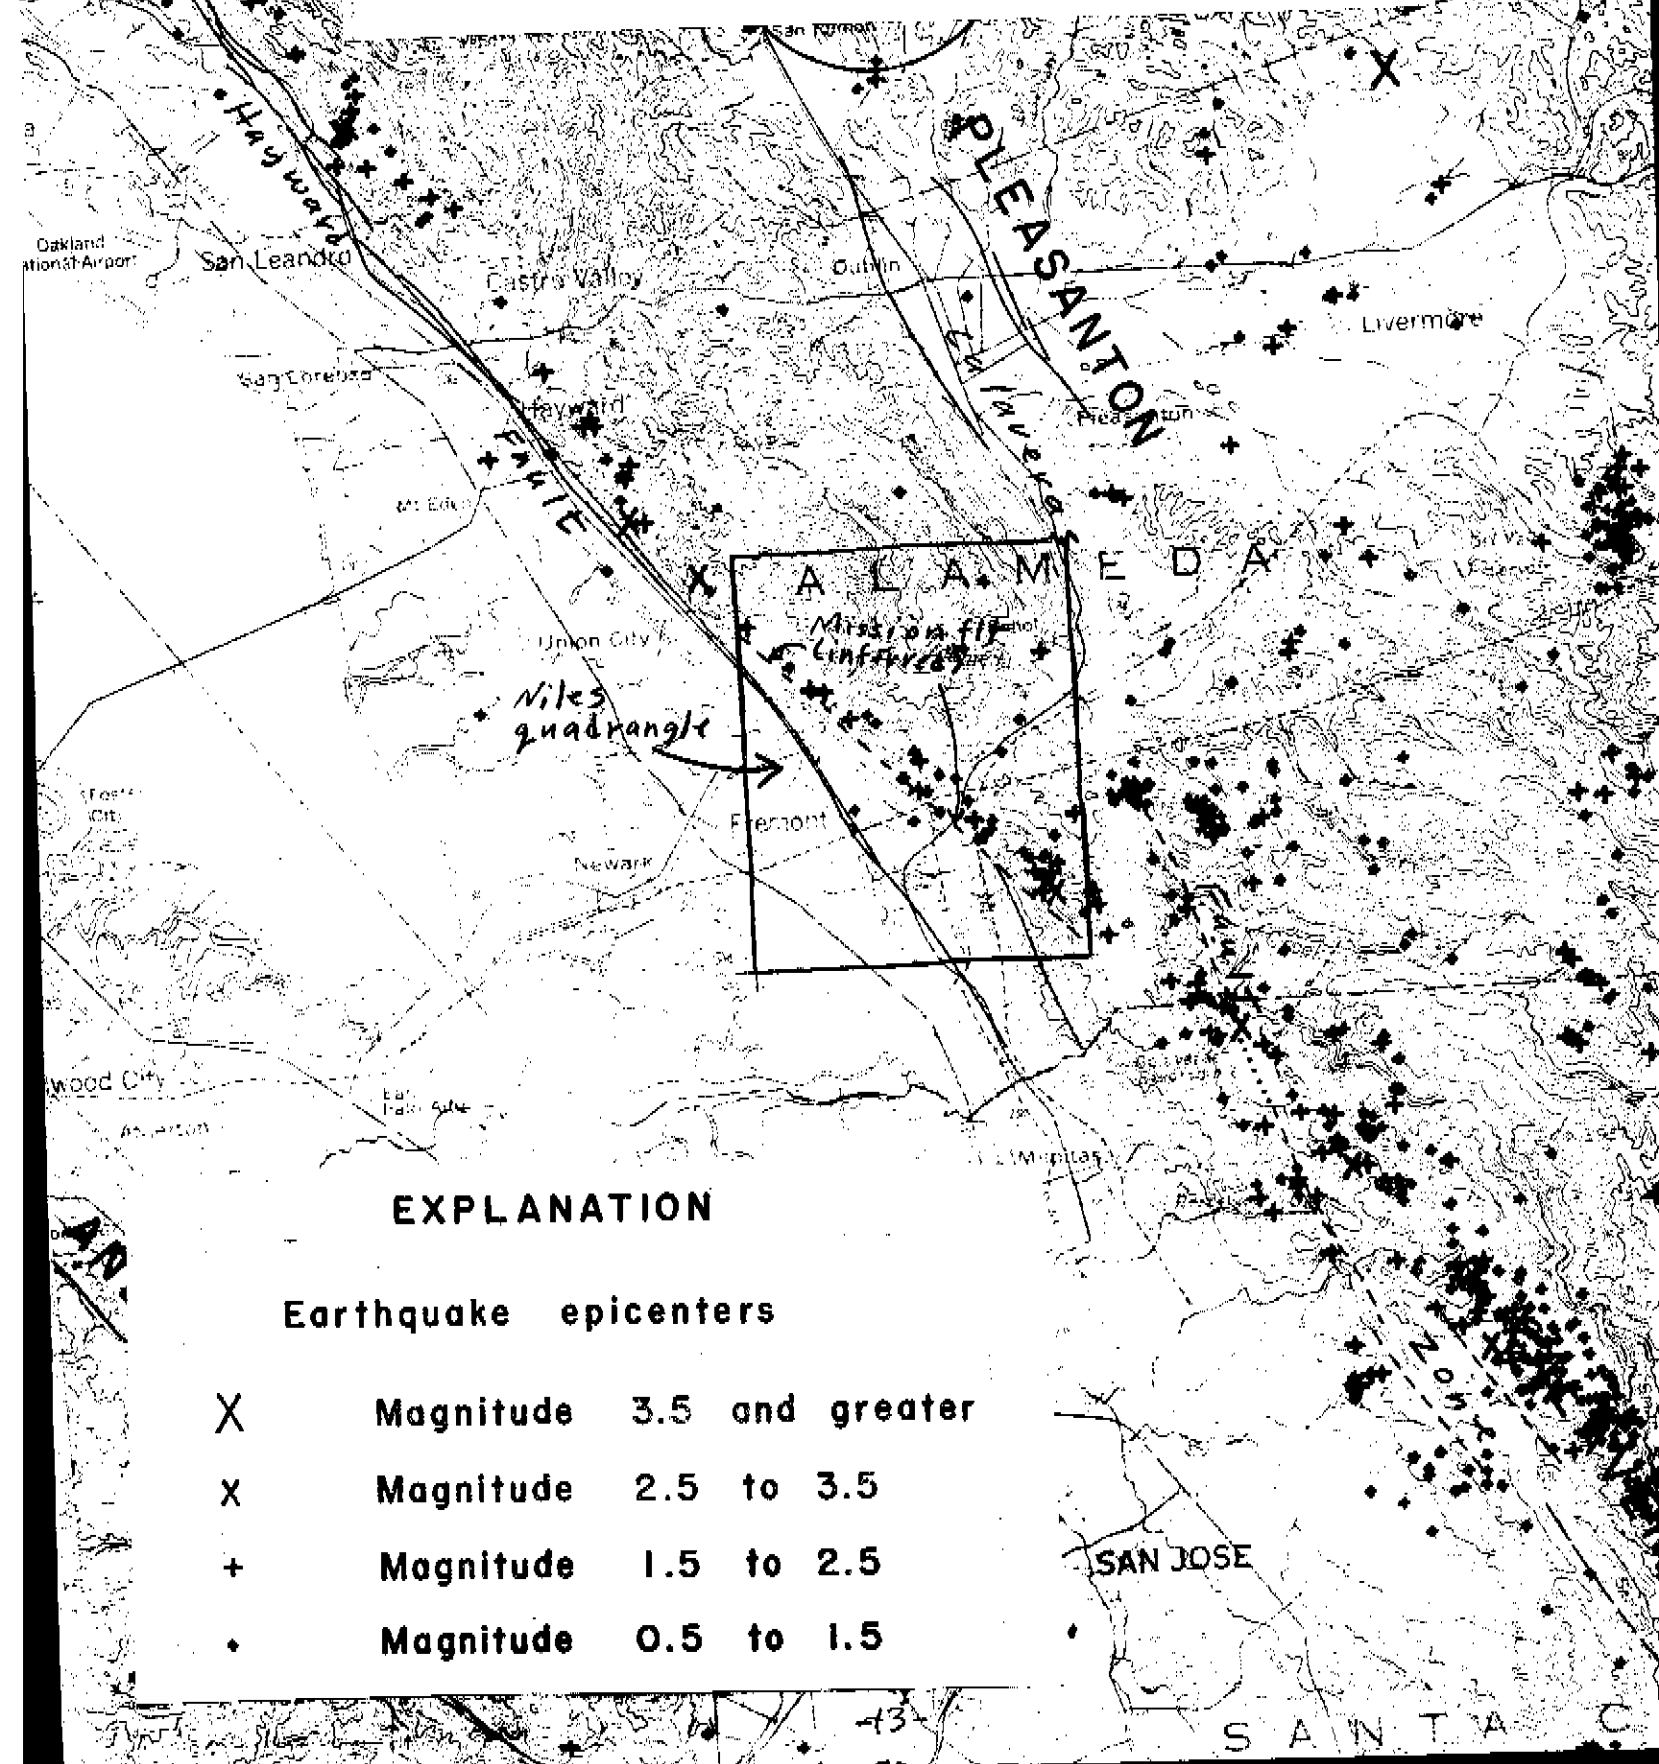
Figure 4 (to FER-88). Earthquake epicenters, 1969-1971, showing fault locations (dashed line = inferred traces) (from Lee and others, 1972).

Another consideration is the microseismicity that coincides with the trace of the Mission fault. This is shown by Lee et al. (1972) and is reproduced as Figure 4. It is tempting to assume that the microseismicity of the Hayward fault transfers to the Calaveras fault via the Mission Creek fault. However, there may be a systematic travel-time error in the epicenters plotted, the Hayward and Calaveras faults may actually dip to the northeast, and the Mission fault probably dips steeply northeast (Hall, 1958). Thus, the epicenter data does not mandate activity on the Mission fault, although historic faulting (at depth) cannot be refuted.
